**Ecological evaluation of the defunct Cooks Run Fish Hatchery  
and its influence on the stream  
(Iron County, Michigan)**

**A project funded by the  
Wilderness Shores Mitigation and Enhancement Fund (MEF)**

**White Water Associates, Inc.  
429 River Lane, P.O. Box 27  
Amasa, MI 49903  
(906) 822-7889**

**Date: February 28, 2025**

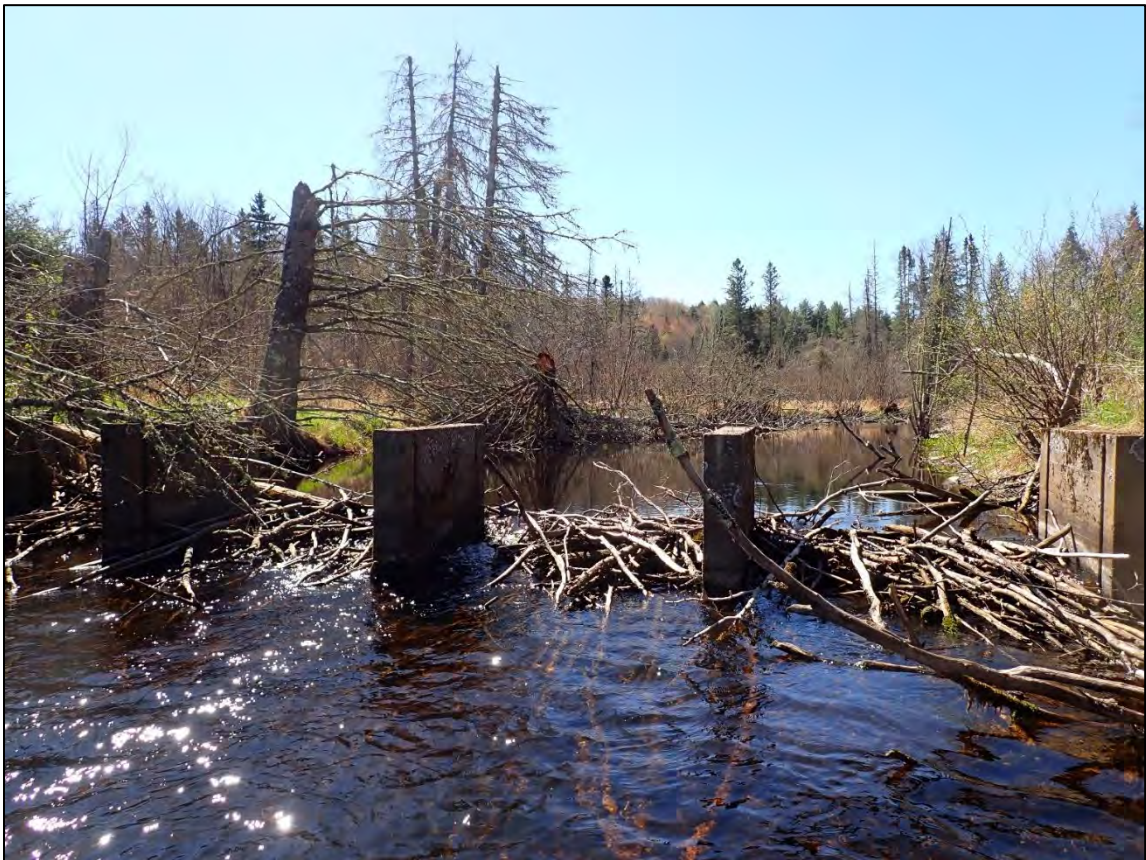
*Photo 4. Concrete abutments of a remnant dam.*

Run channel and underneath the old road (trail) flowing east into the 10-acre swamp that lies south of the diversion ditch. This observation was made during a high-water period and noticeable flow was not always present at this site. There was no bed and bank observed at this crossing point of the trail. Aerial photos show standing water in the 10-acre wetland that may be part of the branch. No obvious confluence of the branch and the Cooks Run channel was present at the downstream end (east end) of the channel in the vicinity of the mapped confluence (Figure 2). Further north along the old road (trail), a small notch in trail allowed some water to drain to the Cooks Run channel although there was not permanent flow. The 10-acre swamp is an important habitat feature for wildlife. Frogs, turtles and wetland-associated birds were present. Figure 2 shows the location of 14 historic dam remnants (light red rectangles) that were part of the water control infrastructure delimiting the fish rearing runs of the Cooks Run facility. At present, these remnants consist of concrete abutments, but no wood structure (Photo 4).
